June 1993

Technical Note

# THE EFFECTS OF HIGH TEMPERATURE ON STRUCTURAL CONCRETE IN NAVY FIREFIGHTING TRAINING FACILITIES

**ABSTRACT** An investigation was completed on the effects of high operational temperatures on a Navy firefighting training facility at the Naval Training Center, Mayport, Florida. Concrete temperature measurements were made during a simulated maximum use training cycle, core samples were retrieved and examined, and predictions of concrete thermal performance were made with a finite element model. It was concluded that the concrete had not deteriorated and should perform well for years of additional service. Refractory linings are not required for new facilities if these facilities are constructed of heat resistant, high strength lightweight concrete and the walls and ceiling near the fire source are protected by a continuous steel plate barrier.

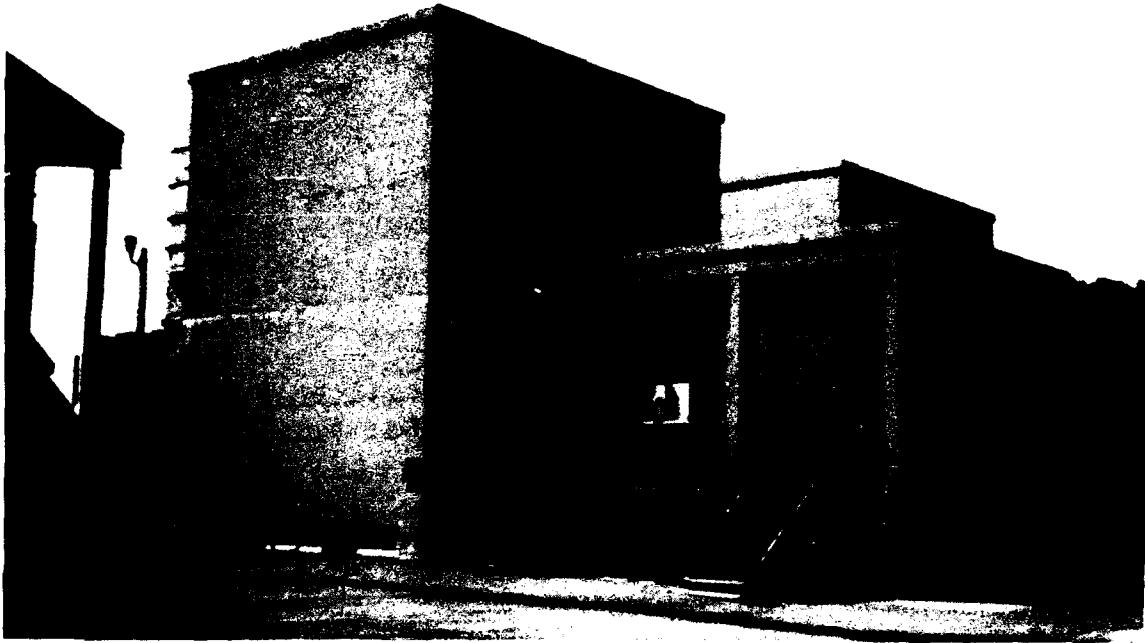
Figure 1

Exterior view of training facility 19F3-B4 at FTC Mayport. The staging area is reached by steel stairways. The fireplace compartment is the large block-like structure to the left of the staging area.

The large size and configuration of training facility 19F3-B4 presented several challenges for the evaluation team (Figure 1). The propane fuel fire is generated in a central fireplace compartment which measures 25 by 13 feet in plan and has a ceiling height of 30 feet (Figures 2 and 3). A roofed, elevated staging area provides a platform from which trainees advance toward the fire with fire suppression gear. The burner and facility control room is on the other side of the fireplace compartment.

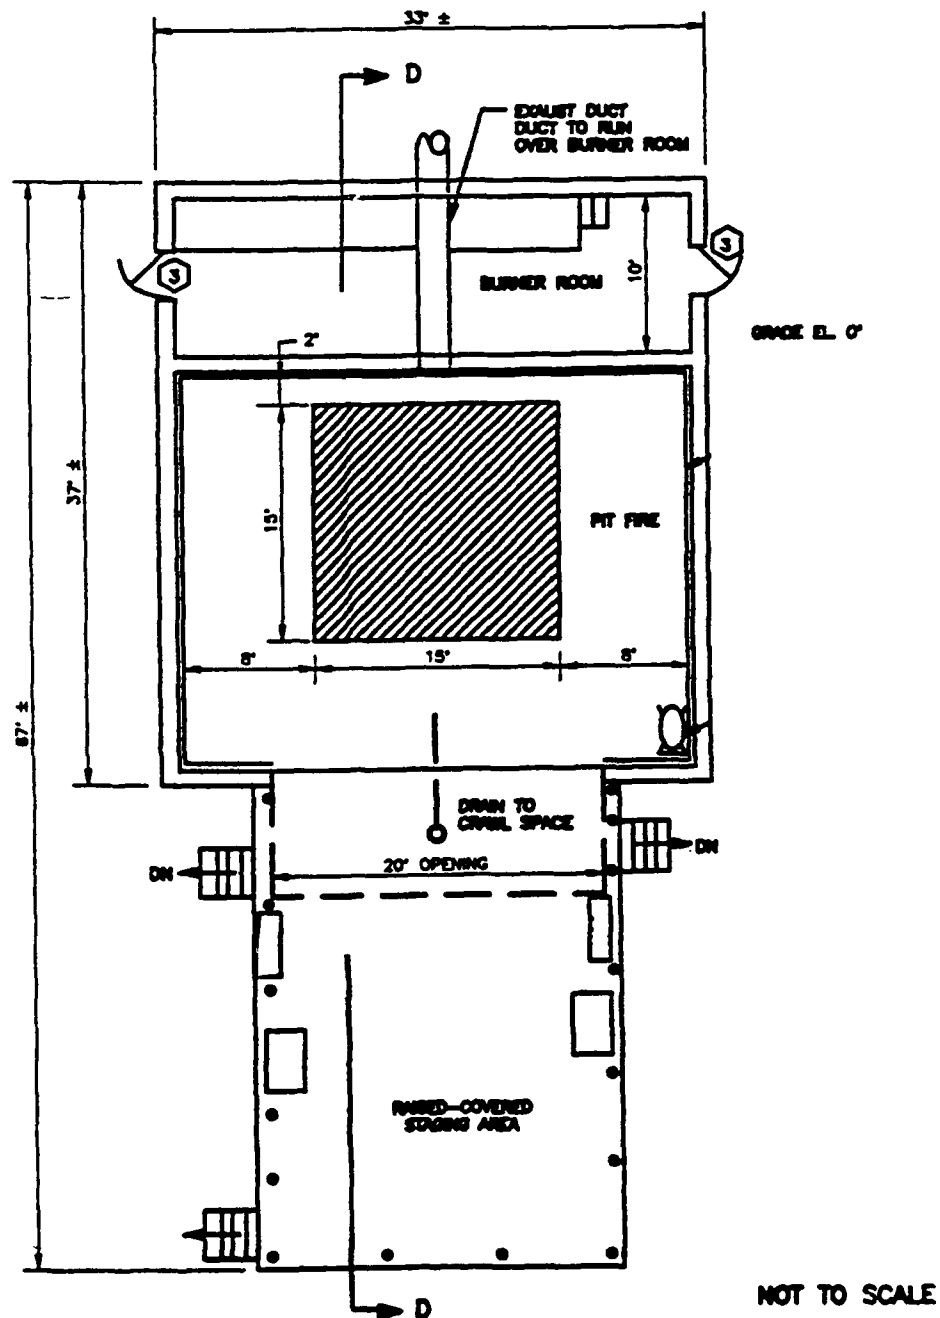
Figure 2  
Plan view of training facility 19F3-B4 from MIL-HDBK-1027/1. Mayport facility lacks the refractory layer and, except for the wall nearest to the pit fire, most of the wall steel plate liner system.

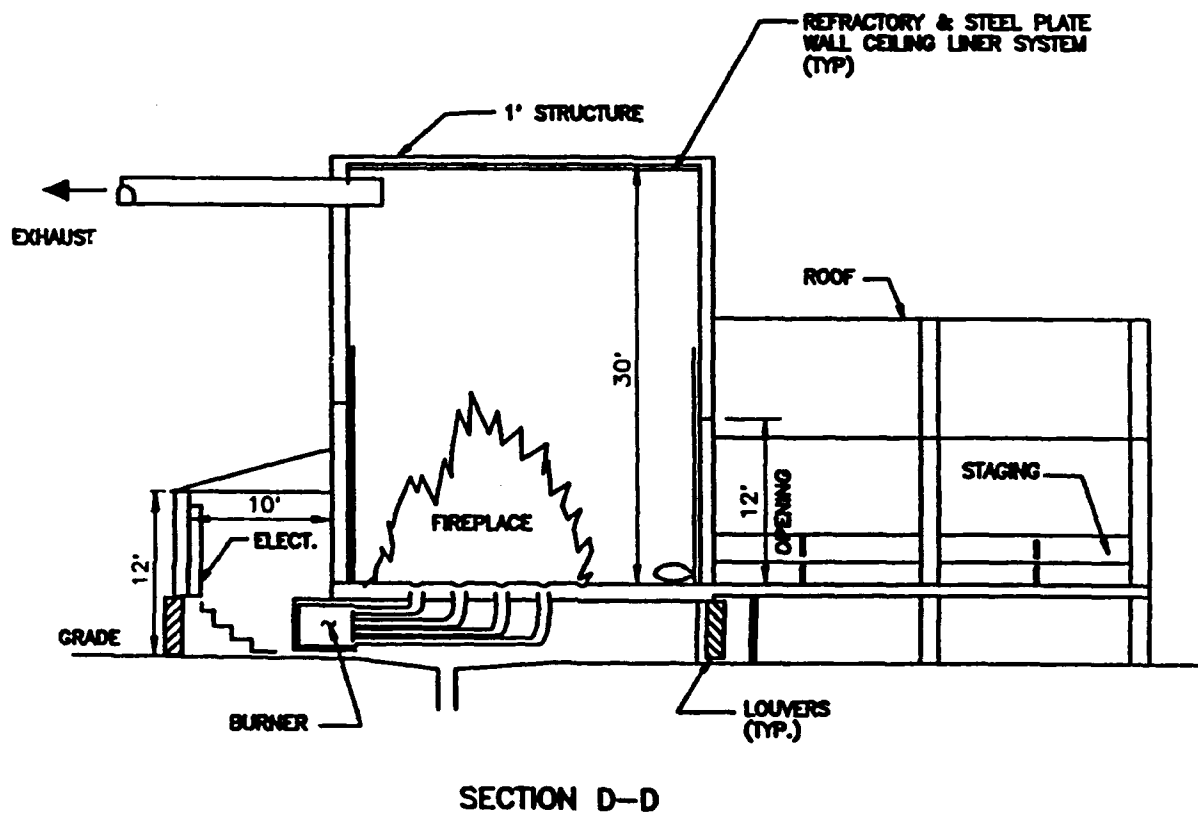
Figure 3  
Elevation view of training facility 19F3-B4 from MIL-HDBK-1027/1.  
Mayport facility lacks the refractory layer and ceiling steel plate liner system.

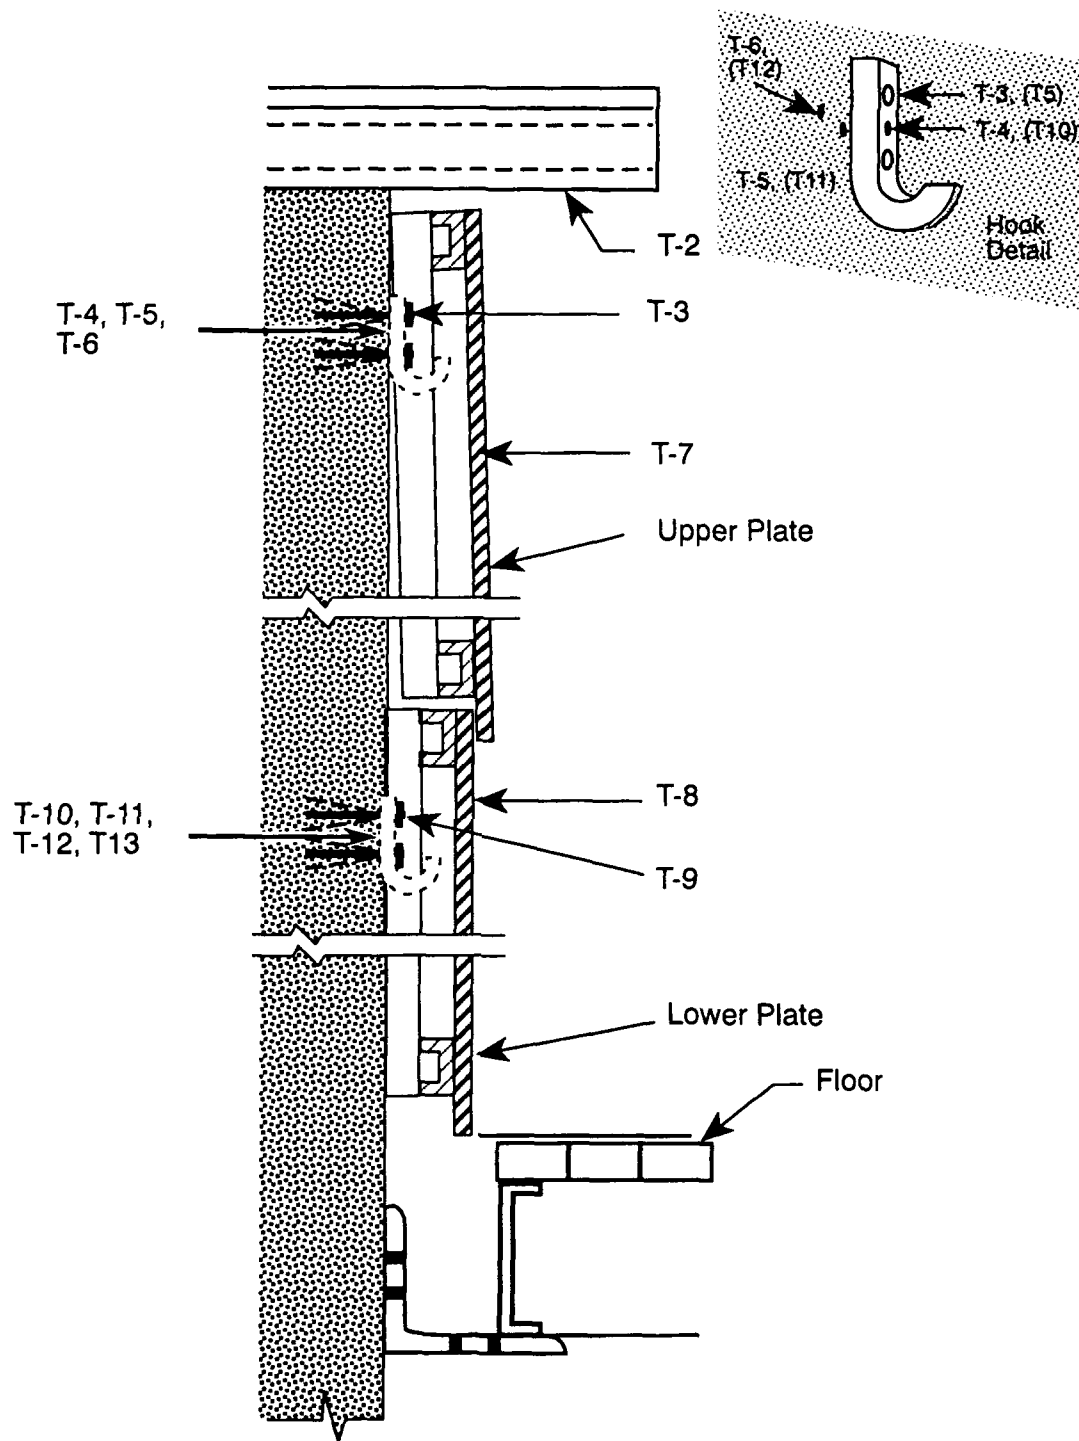
Figure 4  
 Thermocouple locations. The steel plates are supported by bent bar hooks which are anchored to the structural concrete wall.

It was decided to place most of the temperature gauges on the south wall of the fireplace compartment along a vertical line closest to the fire source, thus ensuring that the maximum temperature in the facility would be recorded. It should be noted from Figure 4 that each steel plate is suspended from two hooks which are anchored into the concrete. This suggests the potential for a direct heat path from the exposed steel plates to the concrete underneath. This consideration and the desirability of having gauges located near the ceiling and at an elevation of about 8 feet above the floor (maximum exposure to the fire) led to the following gauge locations:

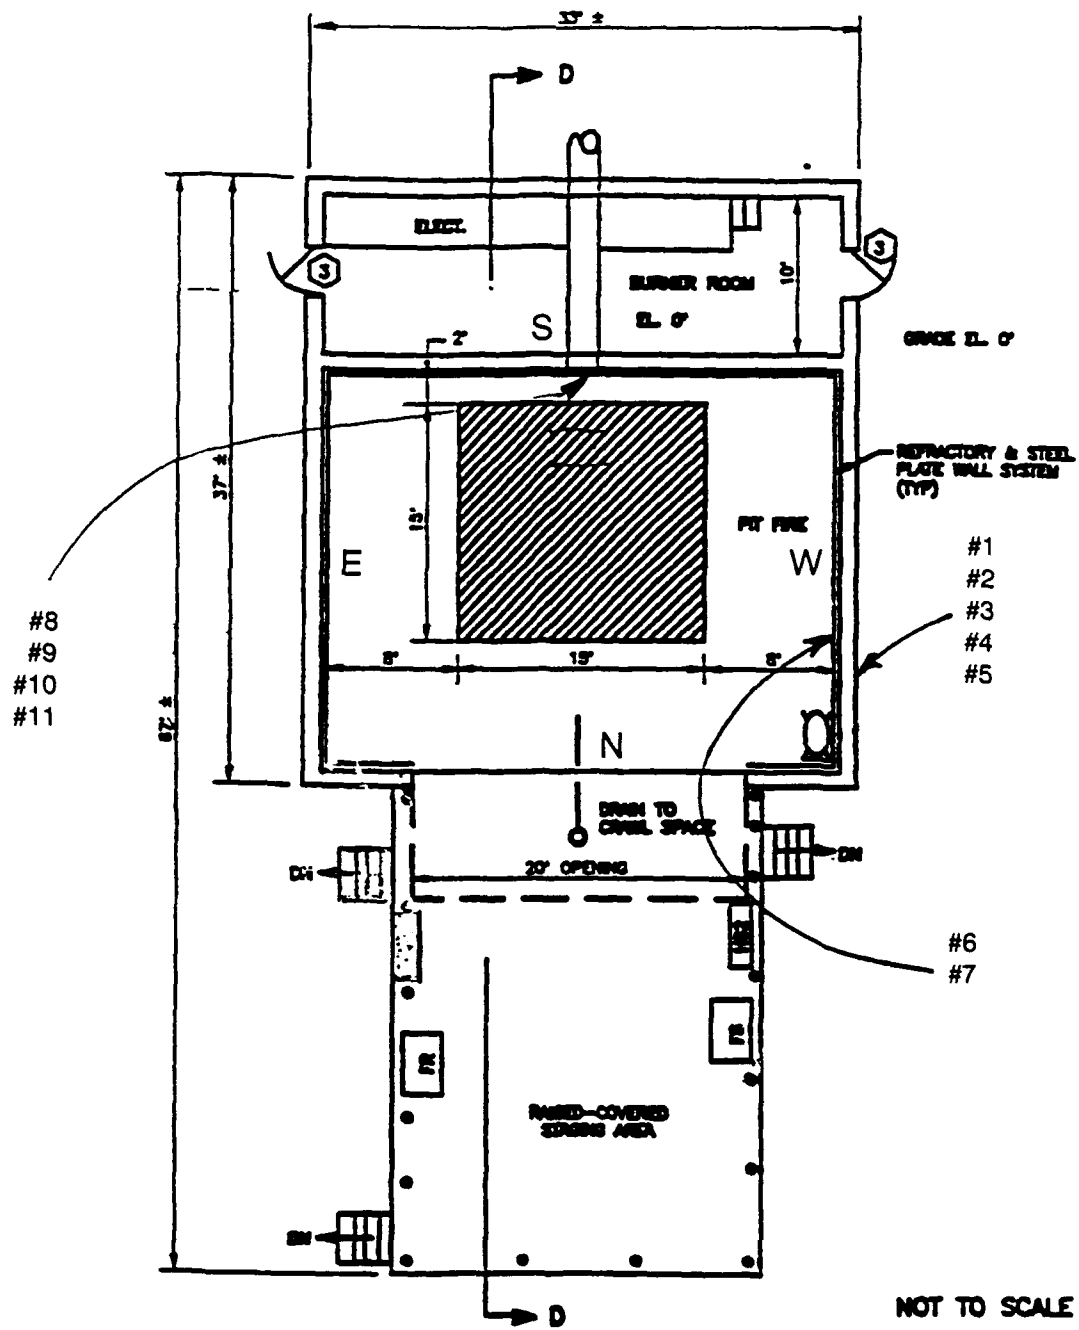
Figure 5  
Plan view of facility 19F3-B4 indicating concrete core locations.

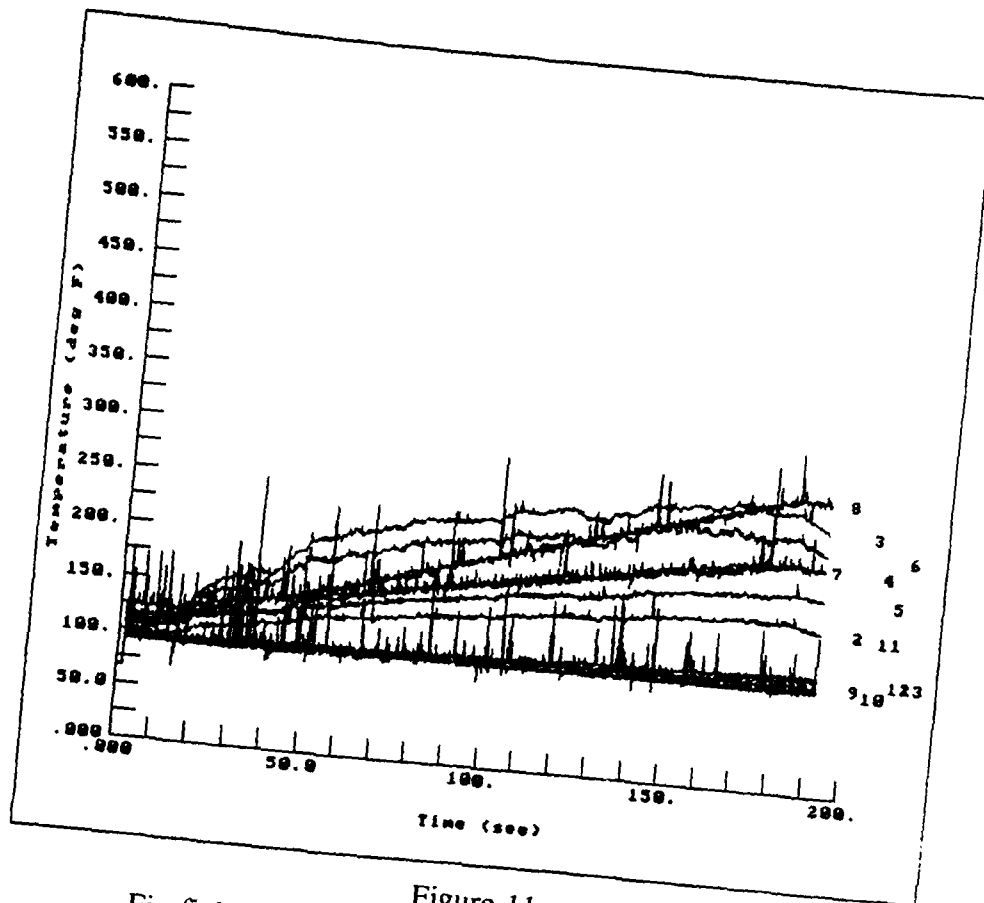
Figure 11  
Firefighting trainer temperature cycling test - Run 1.

At the beginning of the test all of the thermocouples registered temperatures of around 100°F, or slightly higher (Figure 11). Since the ambient air temperature outside the building was about 80°F, the elevated temperatures inside the fireplace compartment were due to the burner pilot fires which had been lit an hour before the start of the test.

Once the pit fire was fully ignited (Figure 11), the thermocouples indicated rising temperatures until the end of the 3-minute burn. On this graph and those that follow, the thermocouple traces tend to cluster in two groups. The group that appears lower on the graphs (traces 2, 9, 10, 11, 12, and 13) are readings from the ceiling gauge and those gauges mounted on the concrete and plate support hardware behind the lower steel plate. The upper group consists of the gauges mounted behind the upper steel plate (traces 3 through 6) and trace 7, which is the output from the thermocouple mounted directly on the upper steel plate. The highest recorded temperatures are from gauge number 8, which is the thermocouple mounted on the lower steel plate.

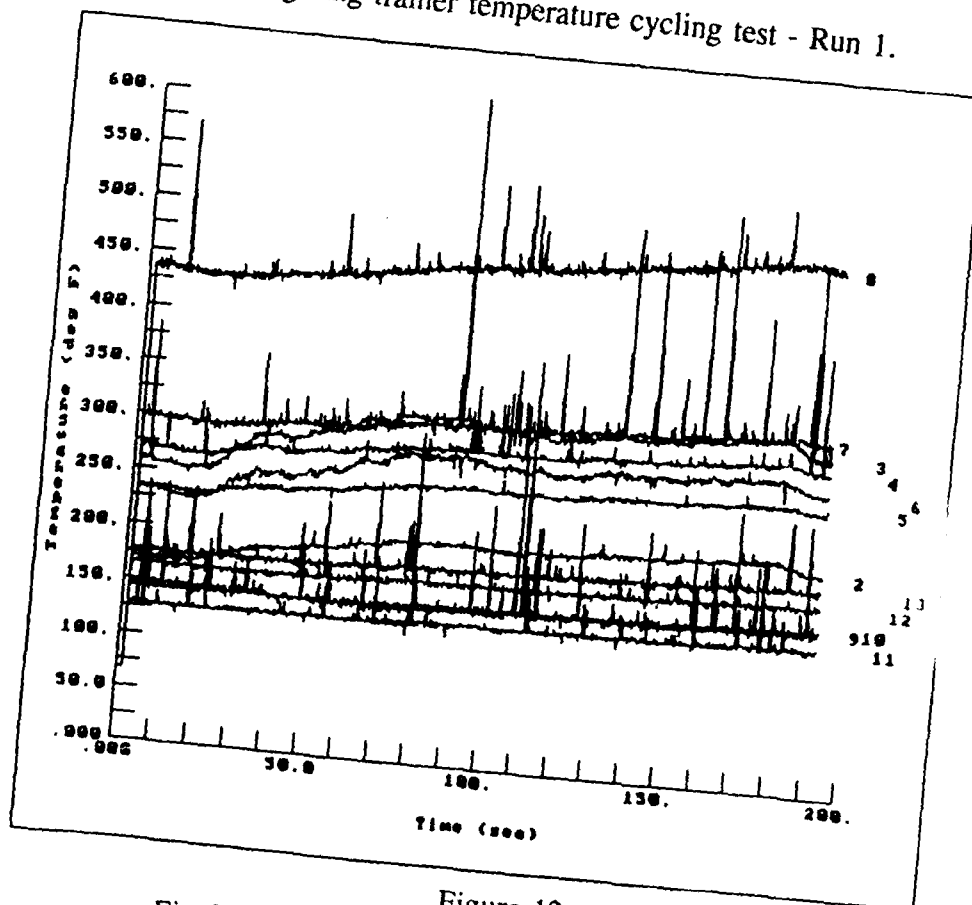
Figure 12  
Firefighting trainer temperature cycling test - Run 5.

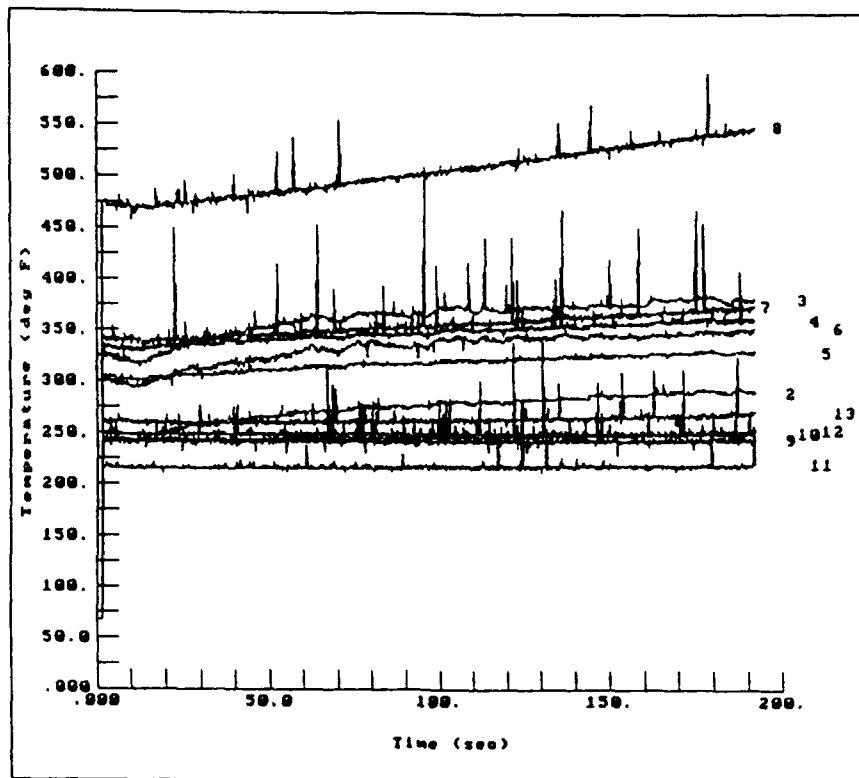
Figure 13  
Firefighting trainer temperature cycling test - Run 15.

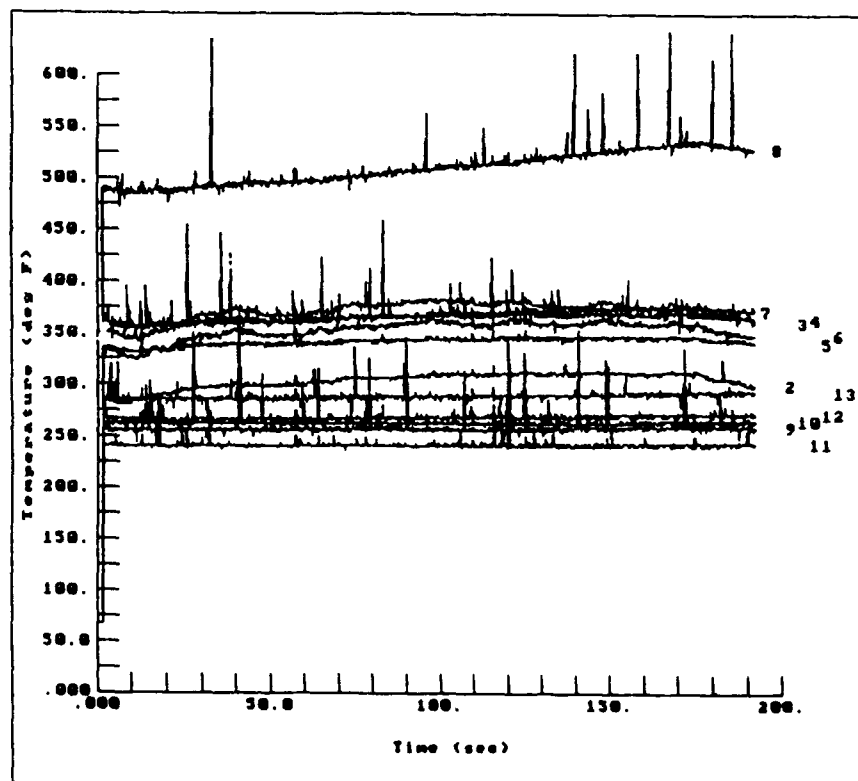
Figure 14  
Firefighting trainer temperature cycling test - Run 28.

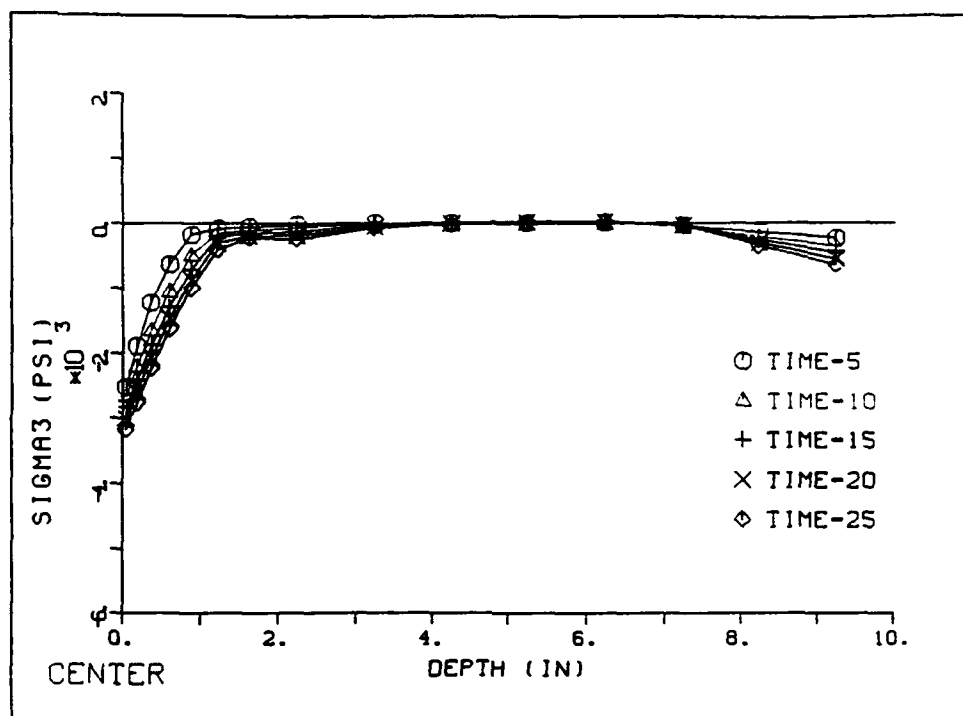
**Results.** Figure 15 shows the third principle stress,  $\sigma_3$ . High compressive stresses (about 3,000 psi) parallel and close to the wall interior face (depth = 0) are observed. Similar compressive stresses, although lower, are observed on the exterior face (depth = 10 inches). These compressive stresses are less than 50 percent of  $f'_c$  and will not affect the integrity of the wall.

Figure 15  
Temperature-induced third principal stress,  $\sigma_3$  - uniform wall.

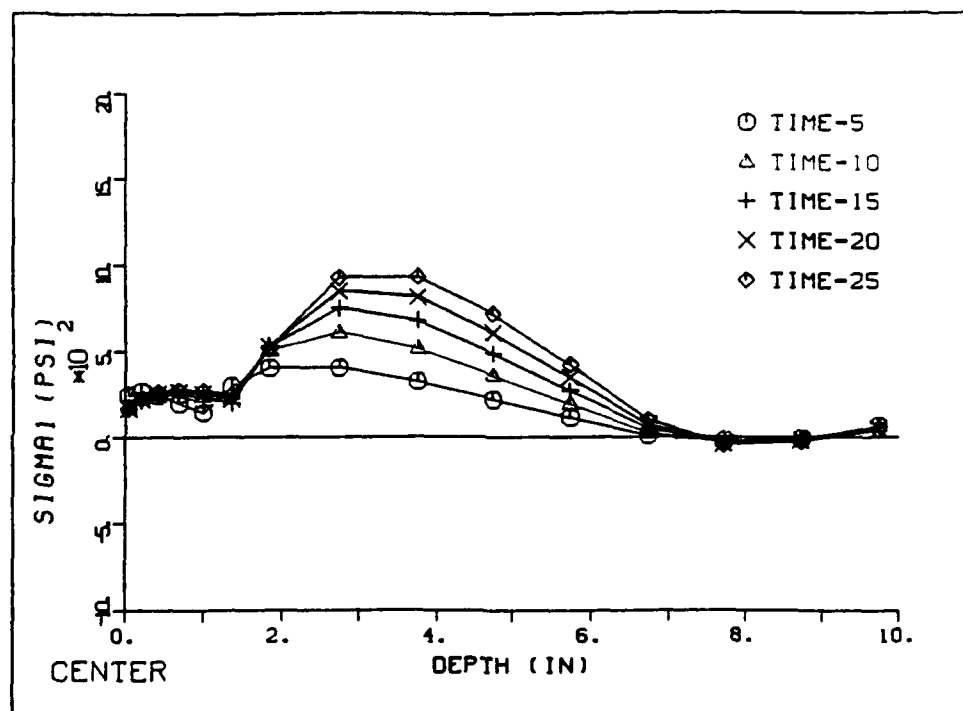
Figure 16 shows the first principal stress,  $\sigma_1$ . It is observed that high tensile stresses (in the wall plane) occur in the central part of the wall. These stresses could induce internal cracking perpendicular to the wall plane which would be present everywhere in the wall. This cracking would not propagate to the wall faces during the heating phase because of the compression existing there (as shown in Figure 15). The presence of steel in this zone could relieve these tensions and prevent these cracks altogether.

Tensile stresses on the order of 270 psi are found on the interior wall face (Figure 16). At this location, these tensile stresses are perpendicular to the wall face, indicating a potential for face delamination which would occur within the first half inch if the concrete tensile strength was inadequate. The available tensile strength is about 420 psi, hence no sudden delamination should occur. However, cyclic thermal loading of the wall will propagate microcracks oriented in the wall plane. This was observed experimentally in Cores 10 and 11 at depths of up to 0.2 inch.

Figure 16  
Temperature-induced first principal stress,  $\sigma_1$  - uniform wall.

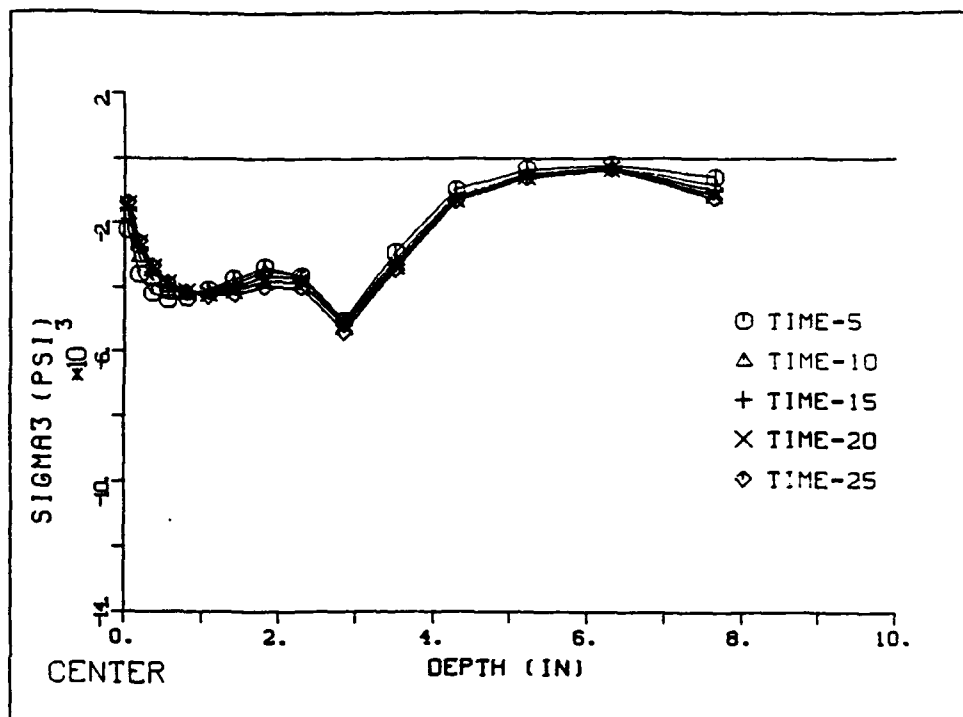
Figure 17  
Temperature-induced third principal stress,  $\sigma_3$  - wall with embedded bolt.

Assuming perfect bond between bolt and concrete, the bolt's longitudinal expansion tries to pull out the concrete on the wall's interior face. This is indicated by the high tensile stresses (above 1,000 psi) on the wall's interior face (depth = 0). In practice, a small conical ring may pull out around the bolt, but most likely the bond will be lost within the first half inch and the concrete will not crack.

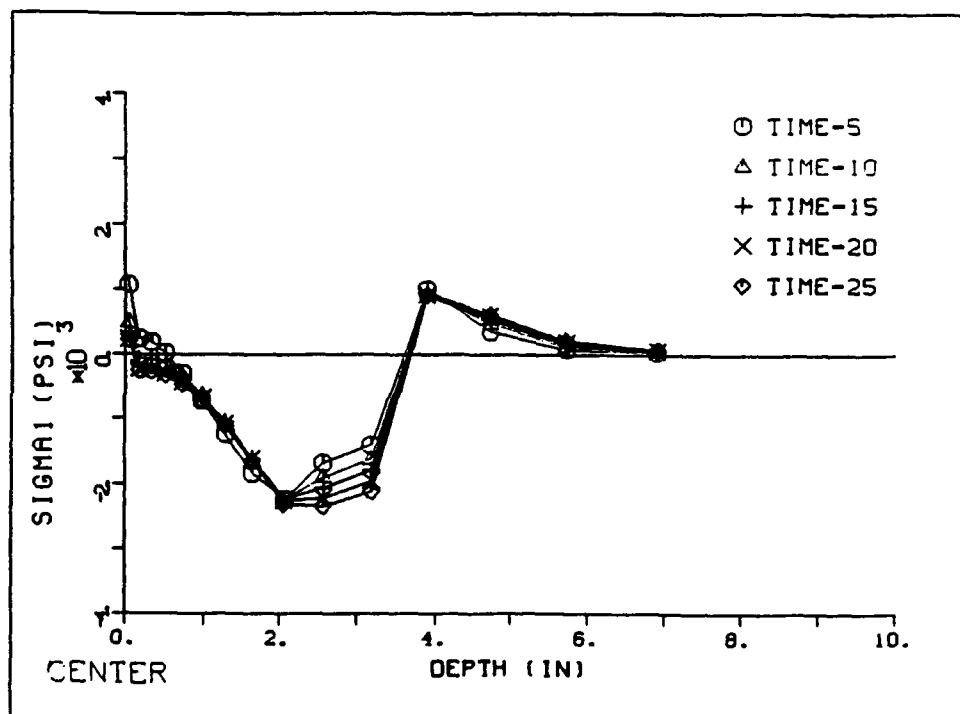
Figure 18  
Temperature-induced first principal stress  $\sigma_1$  - wall with embedded bolt.

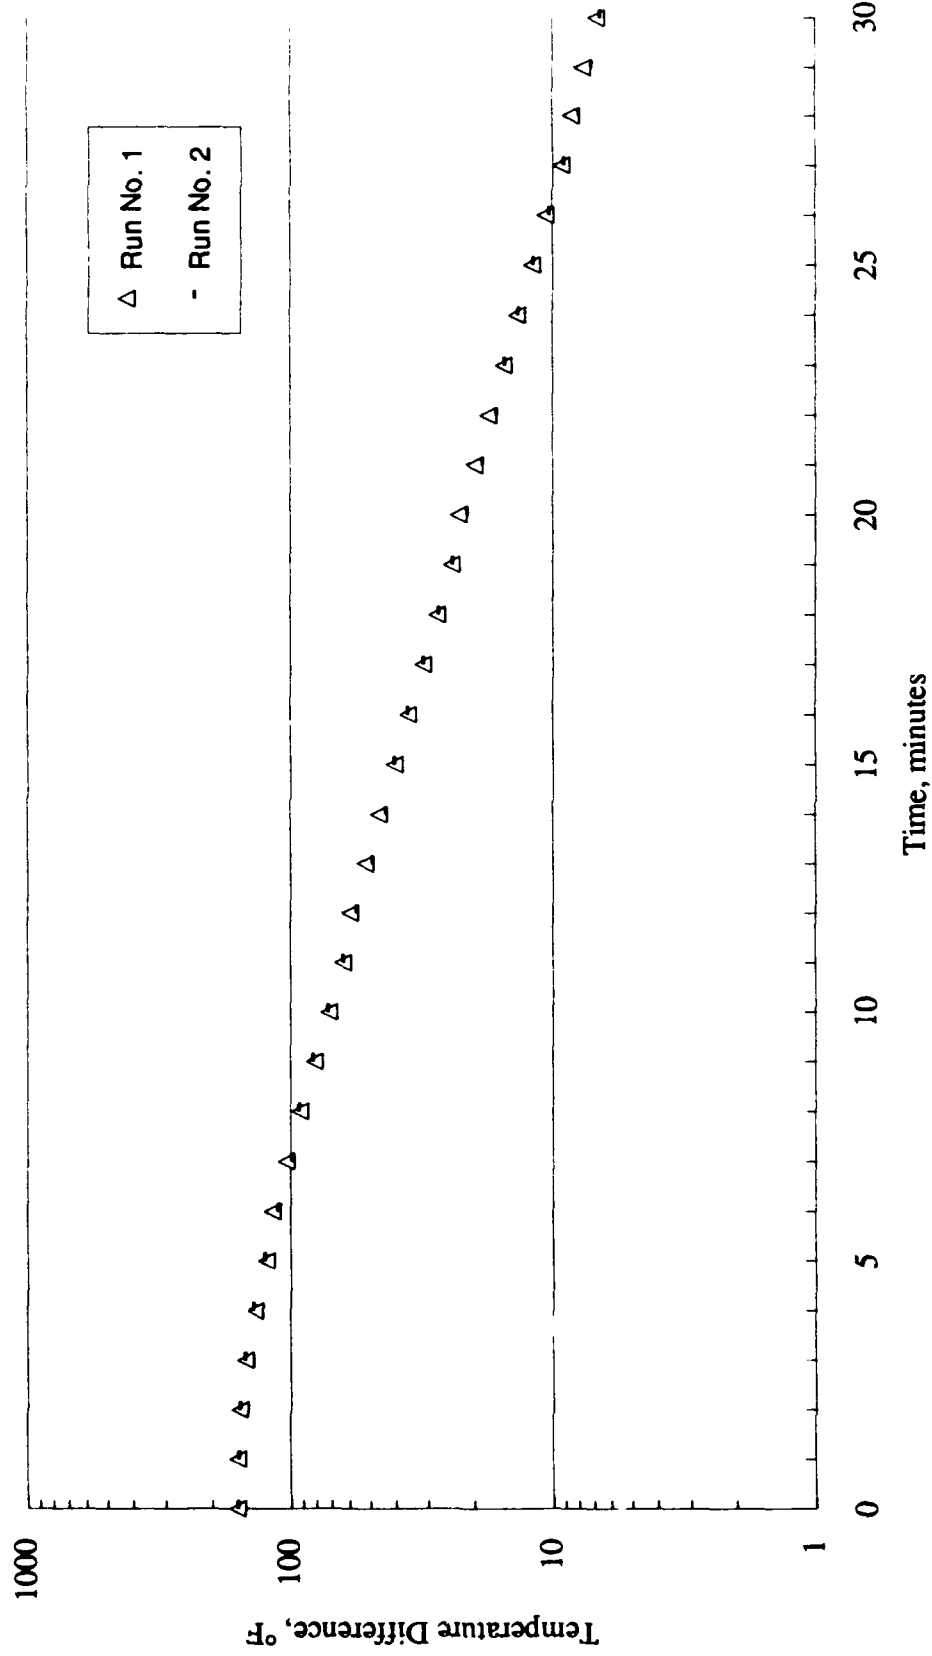
Fig. 1 — Thermal Diffusivity Test Results

Measured thermal diffusivity was 0.029 ft<sup>2</sup>/hr. This test is performed with the specimen submerged in water. The moisture content of the specimen at the end of the test was 10% of the

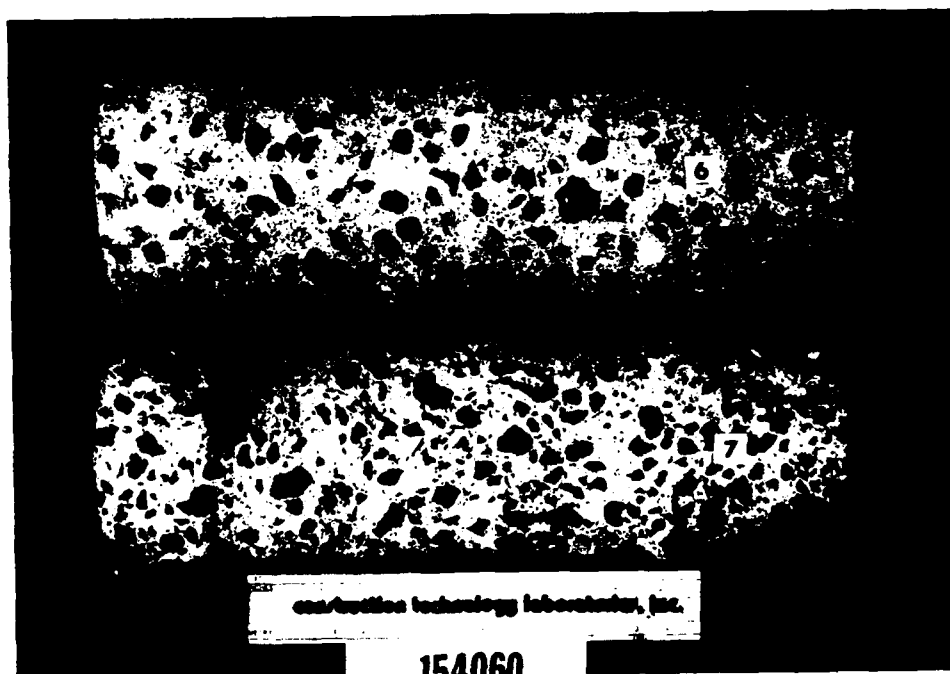
3. The inside wall end of the cores is slightly blackened (Cores 6, 8, 9, and 10) to heavily blackened (cores 7 and 11). Carbonation and concomitant softening of the paste occurs to an average depth of 0.15 in. in Cores 6 and 7, and to a depth of 0.3 to 0.4 in. in Cores 8 through 11. Deeper carbonation (up to 1 in.) is observed around lightweight aggregate particles at the inside wall end of the core, and around cracks.

FIG. 1 INSIDE WALL SURFACE (TOP) AND SIDE VIEW (BOTTOM) OF CORES 6 AND 7 AS RECEIVED FOR EXAMINATION.

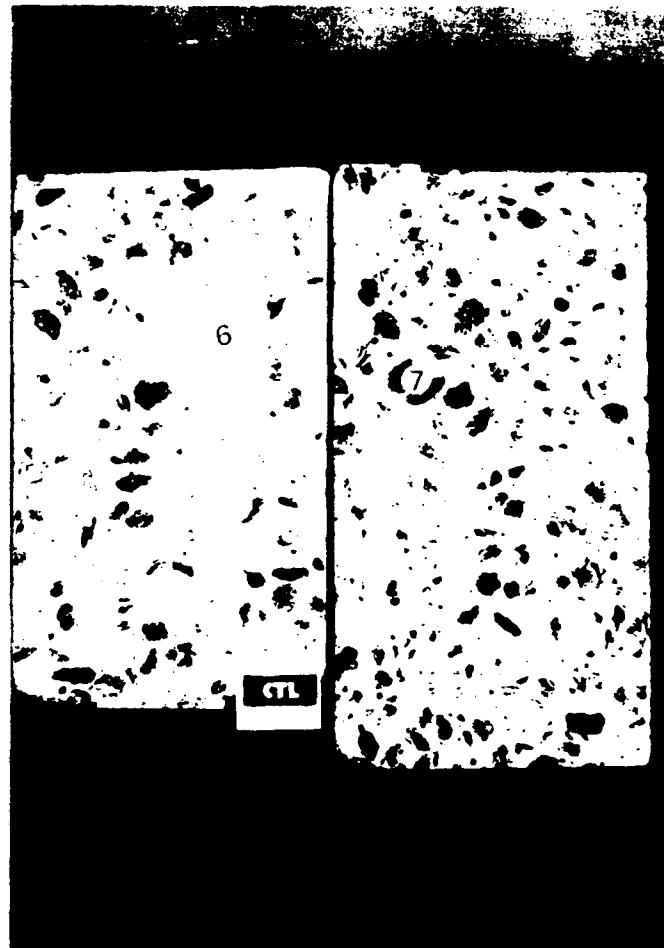
FIG. 4 LAPPED, LONGITUDINALLY SAWN SLICE THROUGH THE INSIDE WALL END OF CORES 6 AND 7. NOTE THE LARGE FOREIGN AGGREGATE IN CORE 6 (ARROW) AND AGGREGATE DISTRIBUTION. CORE 7 CONSISTS OF A LIGHT GRAY CONCRETE AND A DARKER GRAY CONCRETE. NOTE THE IRREGULAR BOUNDARY.

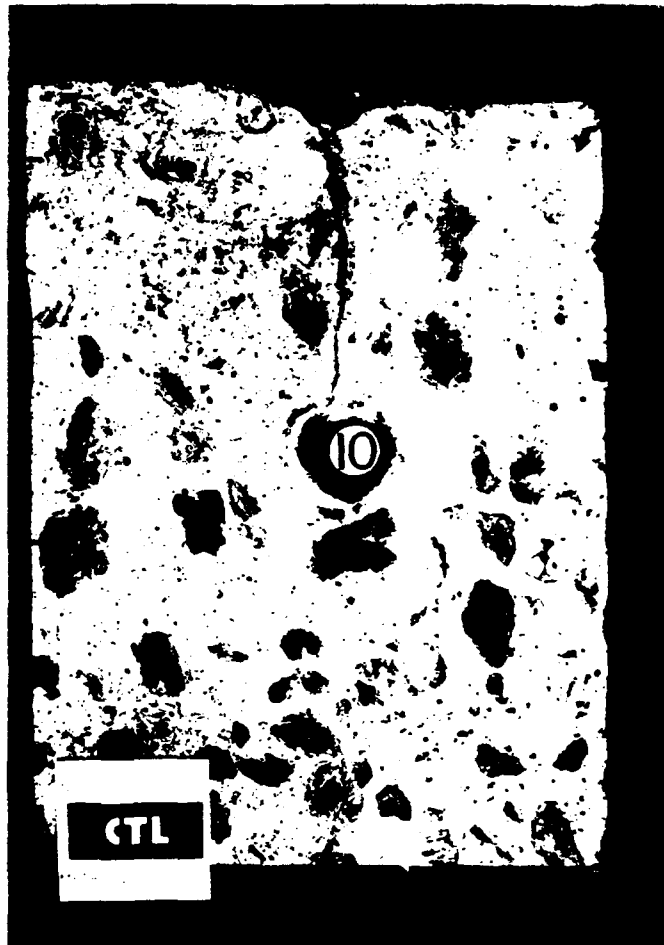
FIG. 5 LAPPED, LONGITUDINALLY SAWN SLICE OF THE INSIDE WALL END OF CORE 10. THE LIGHT GRAY CONCRETE IS CARBONATED NEAR THE CONTACT WITH THE DARKER CONCRETE (ARROW) AND A CRACK OR GAP OCCURS FROM THE REBAR TO THE INSIDE WALL SURFACE.
